CHIMACUM DRAINAGE DISTRICT ANALYSIS

April 2024

Prepared by Jefferson County Conservation District

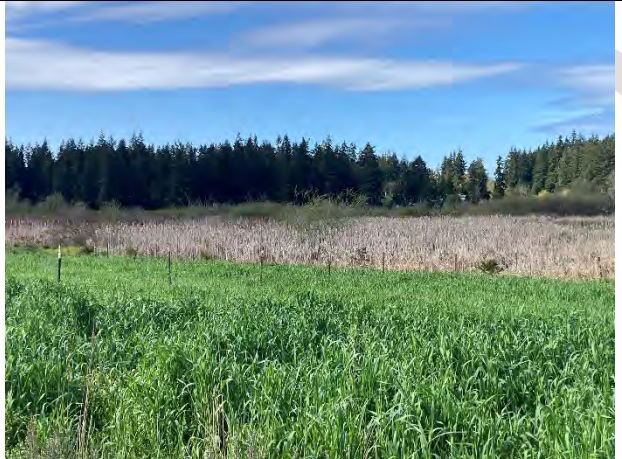
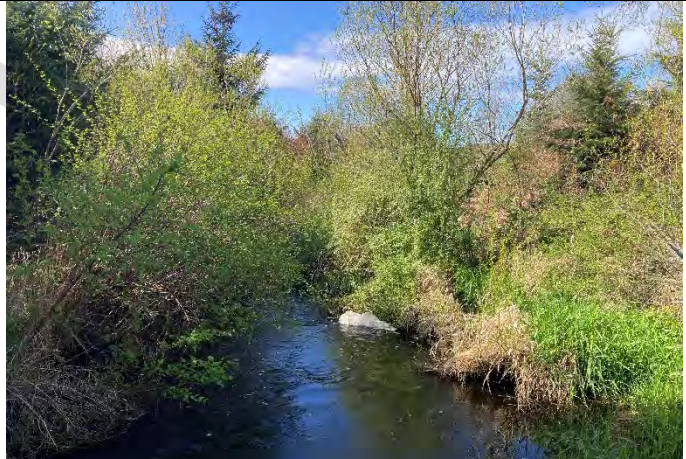
Area, River Miles, Length	160 acres. RM 2.35 to 2.9 – 0.55 miles
Stream Gradient	0.6-1.0%
Channel Conditions	Highly modified. Channel is overgrown with reed canarygrass and barely discernible. No large woody debris.
Tributaries	None identified.
Riparian Characteristics and Tree/Shrub Establishment Potential	Channel flows through a large (~45-ac) wetland that is dominated by reed canarygrass with very little woody vegetation. Successful tree and shrub establishment unlikely due to high water table and competition from reed canarygrass.
Aquatic Vegetation Impact	Severe, mostly reed canarygrass
Ditches	None identified
Flooding	Seasonal flooding in wetland
Culverts, Fish Barriers	None identified
Beaver Dams	3 identified in 2020
Fish Utilization	Adult coho migration, juvenile rearing.
Bacterial Contamination	E. coli Geometric Mean = 58 MPN/100 mL; range = 8-361
Temperature Exceedances	79 days; July-August average daily high = 17.1°C

Dissolved Oxygen	Mean = 7.7 mg/L; range = 5.3-10.0
Farmland Area	20 acres (12% of reach area)
Productive Farmland	10 acres (50% of all farmland), (50% marginal farmland)
Non-Agriculture Area	141 acres (88% of reach area)
Organic Soils	43 acres, approximately 25% of Farmland Area
Downstream Photo	Upstream Photo

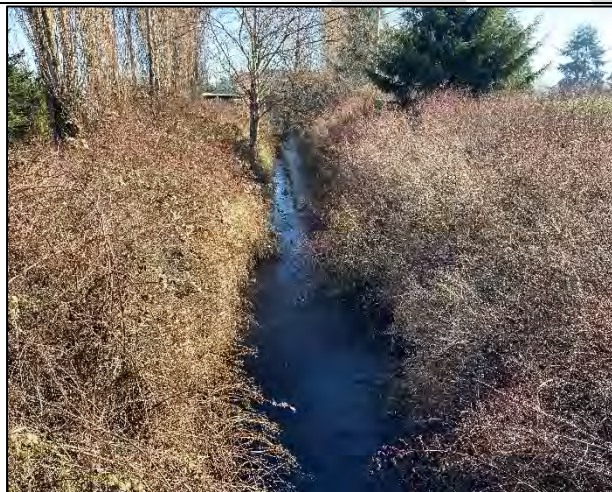
Downstream Stream Corridor

Area, River Miles, Length	277 acres. RM 3.45 to 4.3 ~ 0.9 miles
Stream Gradient	0.1-0.5%
Channel Conditions	Entire reach is highly modified with little complexity.
Tributaries	None identified
Riparian Characteristics and Tree/Shrub Establishment Potential	Narrow forest buffer along downstream and upstream quarters of reach. Good to fair tree and shrub establishment potential.
Aquatic Vegetation Impact	Severe except for forested buffer areas (~RM 4.0-4.1, 4.2-4.3)
Ditches	3.3 miles
Flooding	Rare except for upstream of RM 4.2 where flooding is common and prolonged.
Culverts, Fish Barriers	3 – no fish passage barriers identified
Beaver Dams	None identified
Fish Utilization	Adult coho migration, juvenile rearing.
Bacterial Contamination	E. coli Geometric Mean = 44 MPN/100 mL; range = 15-98
Temperature Exceedances	93 days; July-August average daily high = 19.1°C
Dissolved Oxygen	Mean = 8.0 mg/L; range = 5.7-9.8

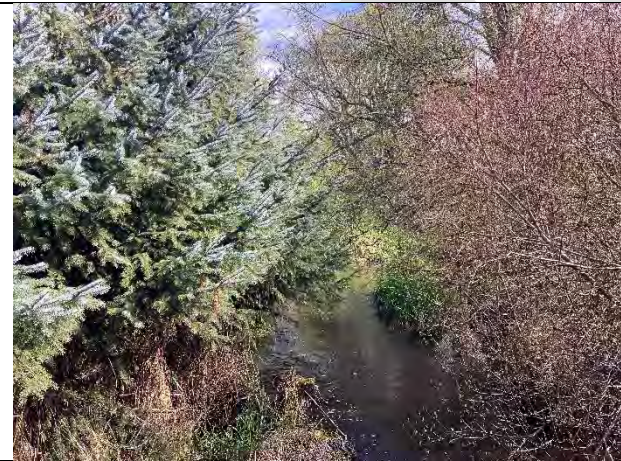
Downstream Photo

Area, River Miles, Length	215 acres. RM 0.0 to 1.0 – 1.0 miles
Stream Gradient	0.1-2.0%, steepest at downstream end of reach.
Channel Conditions	Highly modified with little complexity throughout reach.
Tributaries	None identified.
Riparian Characteristics and Tree/Shrub Establishment Potential	Narrow healthy forest buffer along entire reach. Good tree and shrub establishment potential.
Aquatic Vegetation Impact	Moderate throughout reach.
Ditches	0.7 miles
Flooding	Occasional but not prolonged.
Culverts, Fish Barriers	3 (2 stream, 1 ditch) – no fish passage barriers identified
Beaver Dams	None identified.
Fish Utilization	Adult coho migration, juvenile rearing.
Bacterial Contamination	E. coli Geometric Mean = 32 MPN/100 mL; range = 2-153
Temperature Exceedances	48 days; July-August average daily high = 16.4°C
Dissolved Oxygen	Mean = 9.1 mg/L; range = 7.5-11.1
Farmland Area	39 acres (18% of reach)
Productive Farmland	18 acres (46% of all farmland), (54% marginal farmland)

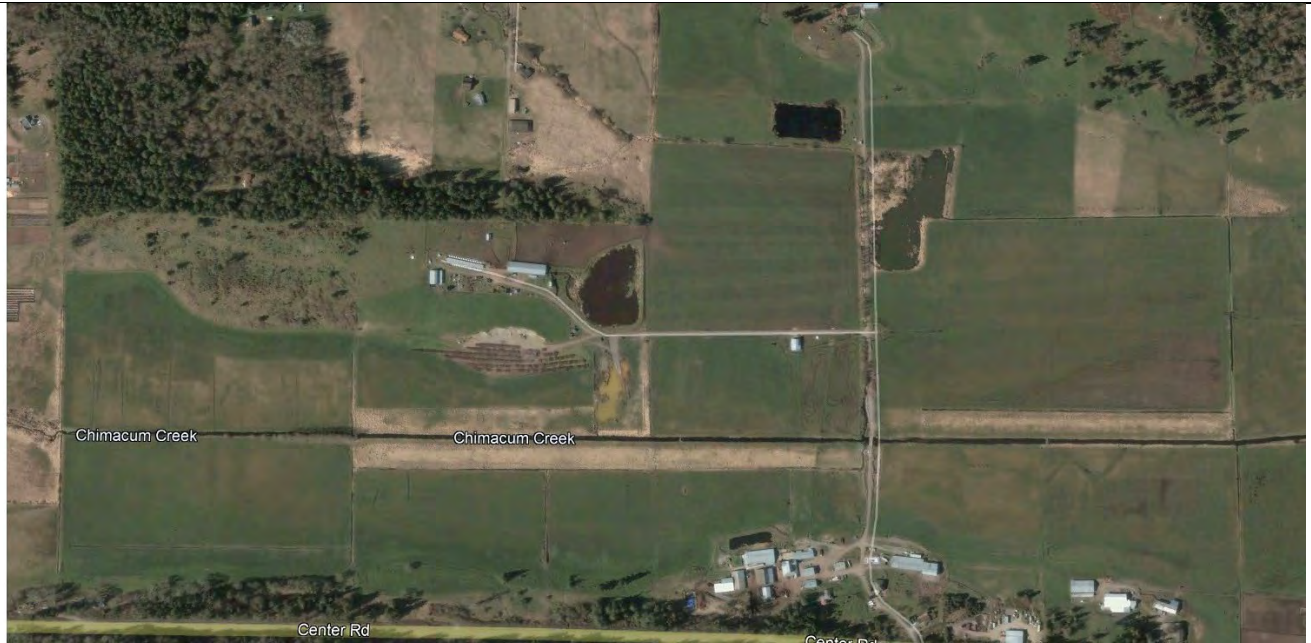
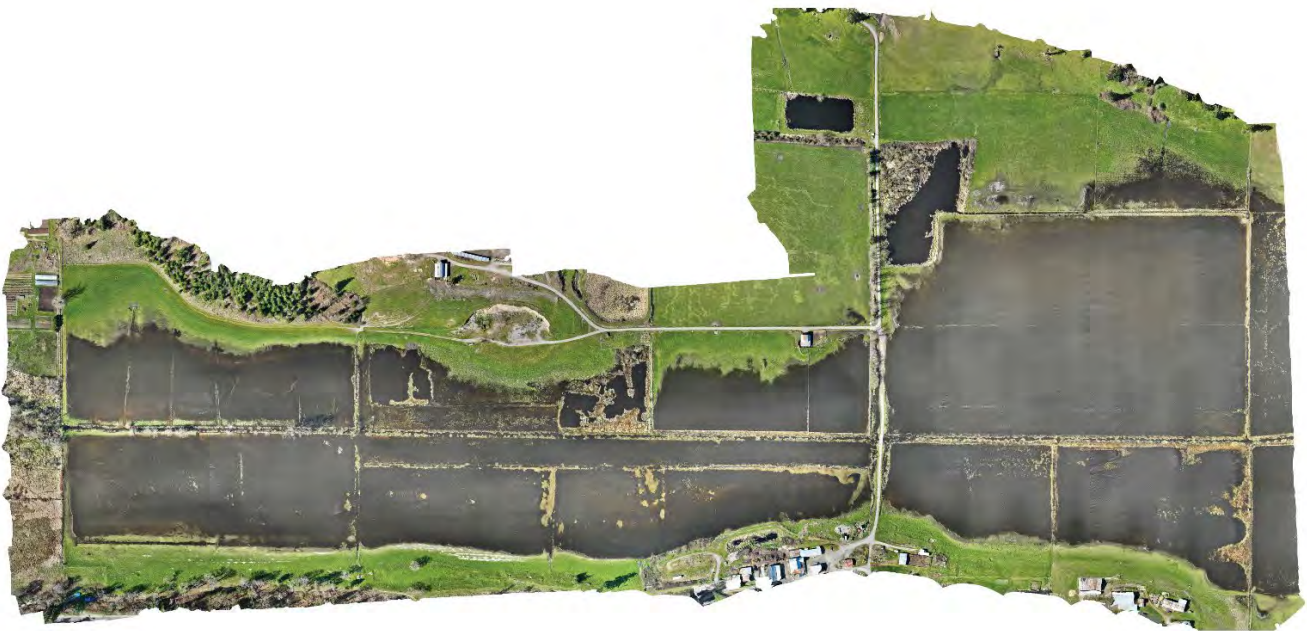
Short Farm – March 2005 (source: Google Earth)

Area, River Miles, Length	558 acres. RM 4.3 to 5.4 – 1.1 miles				
Stream Gradient	0.1-0.5%				
Channel Conditions	Entire channel reach is modified with little complexity.				
Tributaries	Putaansuu Creek – 0.37 miles, all highly modified. Two instream livestock watering structures.				
Riparian Characteristics and Tree/Shrub Establishment Potential	Single-row forest buffer from about RM 4.55 to 5.0. Double-row forest buffer along tributary. Good to fair tree and shrub establishment potential.				
Aquatic Vegetation Impact	Severe throughout reach with some exceptions under forested buffers.				
Ditches	4.75 miles				
Flooding	Common, widespread, and prolonged throughout reach. Floodplain is important overwintering habitat for trumpeter swans.				
Culverts, Fish Barriers	5 (2 stream, 3 ditch) – 3 fish passage barriers				
Beaver Dams	1 identified in 2020				
Fish Utilization	Adult coho migration, juvenile rearing.				
Bacterial Contamination	No data				
Temperature Exceedances	96 days; July-August average daily high = 19.0°C				
Dissolved Oxygen	Mean = 9.1 mg/L; range = 4.6-11.9				
Farmland Area	406 acres (73% of reach area)				
Productive Farmland	219 acres (54% of all farmland), (46% marginal farmland)				
Non-Agriculture Area	152 acres (27% of reach area)				
Organic Soils	245 acres, approximately 60% of farmland				
<table border="1" style="width: 100%; border-collapse: collapse;"> <tr> <td style="width: 50%; text-align: center;">Downstream Stream Corridor</td> <td style="width: 50%; text-align: center;">Upstream Stream and Field</td> </tr> <tr> <td style="text-align: center;"> </td> <td style="text-align: center;"> </td> </tr> </table>		Downstream Stream Corridor	Upstream Stream and Field	 	 
Downstream Stream Corridor	Upstream Stream and Field

No inundation in March of 2005.
Extensive inundation (areas in gray) in March of 2024 following less than average precipitation.

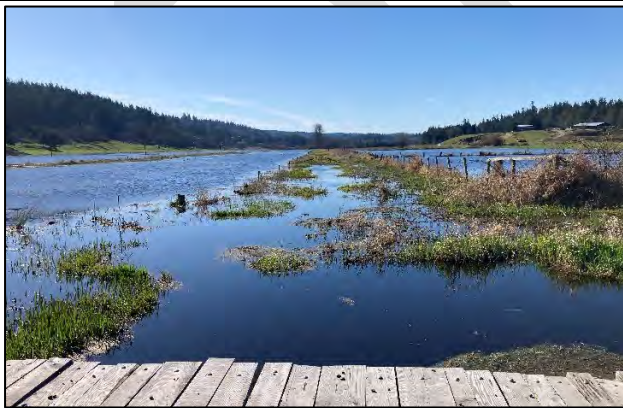
Downstream Stream and Field

Area, River Miles, Length	943 acres. RM 5.4 to 7.0 – 1.6 miles
Stream Gradient	0.1-2.0%, steeper gradient un upstream half mile.
Channel Conditions	Highly modified channel with little complexity, except for RM 6.1 to RM 6.4 where meandering channel was constructed in late 1990s.
Tributaries	Naylor's Creek – 4.1 miles, downstream mile is highly modified.
Riparian Characteristics and Tree/Shrub Establishment Potential	No forest buffer RM 5.3-6.1. Restored forest buffer along reconstructed reach. Limited forest buffer on upstream half of reach. Narrow forest buffer along full reach of Naylor's Creek. Good tree and shrub establishment potential on upstream half of reach and along Naylor's Creek.
Aquatic Vegetation Impact	Severe from downstream end of reach to RM 6.1. (~0.8 mi) and on most ditches. Minimal in forested reaches.
Ditches	4.2 miles
Flooding	Common, widespread, and prolonged from about RM 6.1 downstream. Floodplain is important overwintering habitat for trumpeter swans.

Culverts, Fish Barriers	8 (4 stream, 4 ditch) – 2 fish passage barriers
Beaver Dams	2 identified in 2020.
Fish Utilization	Adult coho migration, juvenile rearing in both main stem and tributary. Coho spawning in Naylor's Creek and possibly in restored reach.
Bacterial Contamination	E. coli Geometric Mean = 41 MPN/100 mL; range = 17-120
Temperature Exceedances	93 days; July-August average daily high = 19.9°C
Dissolved Oxygen	Mean = 9.2 mg/L; range = 6.9-11.4
Farmland Area	403 acres (43% of reach area)
Productive Farmland	73 acres (18% of all farmland), (82% marginal farmland)
Non-Agriculture Area	540 acres (57% of reach area)
Organic Soils	232 acres, approximately 58% of farmland

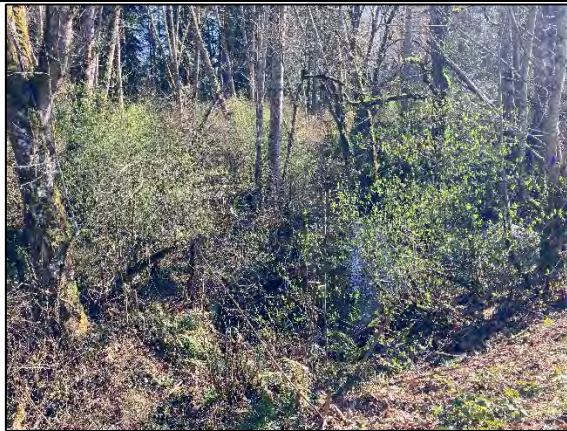
Downstream Stream Corridor

Area, River Miles, Length	532 acres. RM 7.0 to 8.2 ~ 1.15 miles
Stream Gradient	0.1-0.5%, steeper gradient in downstream
Channel Conditions	Highly modified with little complexity, except 0.3 miles of downstream reach.
Tributaries	~1.6 miles, all unnamed.
Riparian Characteristics and Tree/Shrub Establishment Potential	No forest buffer, except for downstream 0.2 miles. Poor tree and shrub establishment potential due to high water table, reed canarygrass competition.
Aquatic Vegetation Impact	Severe from RM 7.3 to 8.2 (~0.9 mi) and on most ditches.
Ditches	4.3 miles
Flooding	Common, widespread, and prolonged upstream of Center Rd crossing (RM 7.4).
Culverts, Fish Barriers	12 (3 stream, 9 ditch) – 8 fish passage barriers
Beaver Dams	1 identified in 2020 near Egg & I Road.
Fish Utilization	Adult coho migration, juvenile rearing.
Bacterial Contamination	E. coli Geometric Mean = 112 MPN/100 mL; range = 5-687

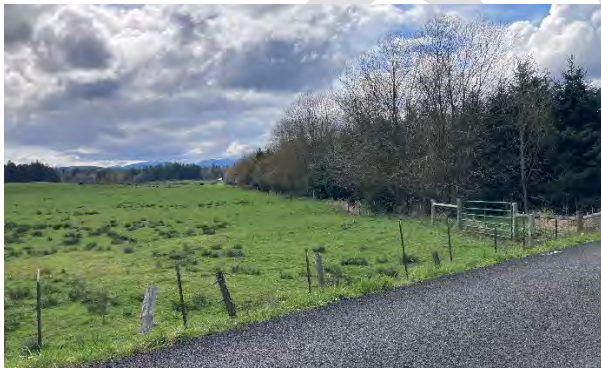
Downstream Stream & Field

Area, River Miles, Length	884 acres. RM 8.2 to 9.4 – 1.2 miles
Stream Gradient	0.6-2.0%, steepest from about RM 9.0 to 9.4
Channel Conditions	Highly modified with little complexity, except for upstream 0.4 miles of reach.
Tributaries	~2.0 miles, all unnamed.
Riparian Characteristics and Tree/Shrub Establishment Potential	Narrow forest buffer RM 8.2-8.4, established forest buffer RM 9.0-9.4. Newly planted hedgerow buffer RM 8.4-8.8. Fair tree and shrub establishment potential.
Aquatic Vegetation Impact	Severe from RM 8.4 to 8.9 (~0.5 mi) and on most ditches
Ditches	7.85 miles
Flooding	Occasional but not prolonged along mainstem, common and severe on ditches.
Culverts, Fish Barriers	7 (2 stream, 5 ditch) – 4 Fish Passage Barriers
Beaver Dams	None identified
Fish Utilization	Adult coho migration, juvenile rearing. Possible spawning in upstream 0.4 miles.
Bacterial Contamination	E. coli Geometric Mean = 77 MPN/100 mL; range = 1-2420

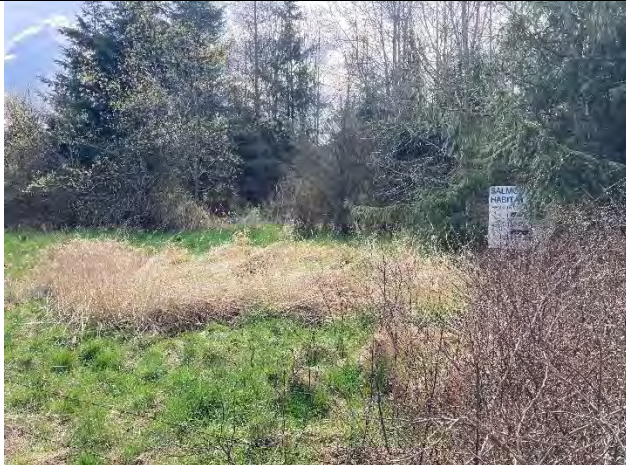
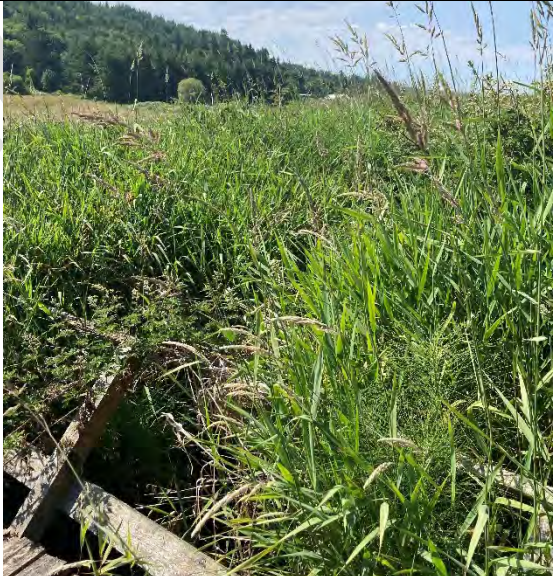
Area, River Miles, Length	609 acres. RM 1.0 to 2.4 – 1.4 miles	
Stream Gradient	0.1-0.5%	
Channel Conditions	Highly modified with little complexity throughout reach. No discernable channel in portions of reach.	
Tributaries	None identified	
Riparian Characteristics and Tree/Shrub Establishment Potential	Previously planted forest buffer along downstream 0.2 miles and upstream 0.3 miles of reach. Downstream buffer in decline due to beaver and flooding. Poor tree and shrub establishment potential due to high water table.	
Aquatic Vegetation Impact	Severe impacts from RCG throughout reach except under established forest buffer. Impacts to channel from willows.	
Ditches	6.1 miles	
Flooding	Common, widespread, and prolonged.	
Culverts, Fish Barriers	3 (2 stream, 1 ditch) – no fish passage barriers identified	
Beaver Dams	Numerous, especially where forested buffers have been re-established.	
Fish Utilization	Adult coho migration, juvenile rearing.

Bacterial Contamination	E. coli Geometric Mean = 24 MPN/100 mL; range = 3-344	
Temperature Exceedances	76 days; July-August average daily high = 17.0°C	
Dissolved Oxygen	Mean = 5.7 mg/L; range = 1.6-9.0	
Farmland Area	391 acres (64% of reach)	
Productive Farmland	215 acres (55% of all farmland), (45% marginal farmland)	
Non-Agriculture Area	219 acres (36% of reach)	
Organic Soils	247 acres, approximately 63% of farmland	
	Downstream Photo	Upstream Photo

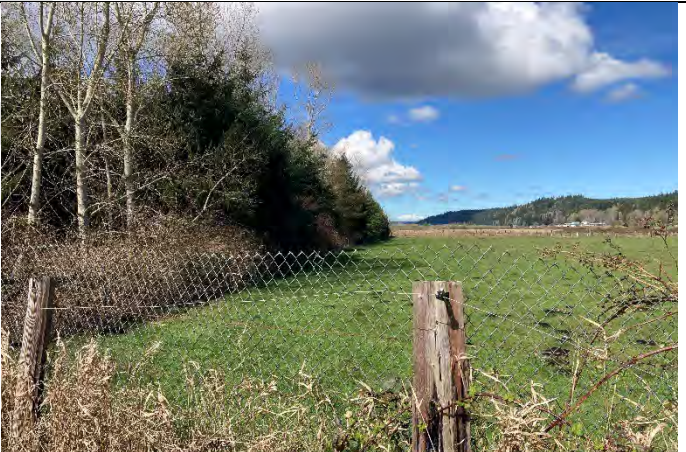
Area, River Miles, Length	436 acres. RM 2.4 to 3.5 – 1.1 miles	
Stream Gradient	0.1-0.5%	
Channel Conditions	Highly modified with little complexity throughout reach.	
Tributaries	2.3 miles, all unnamed	
Riparian Characteristics and Tree/Shrub Establishment Potential	Previously planted forest buffer along upstream 0.5 miles of reach. Much of buffer is in poor condition due to beaver and flooding. Poor tree and shrub establishment potential due to high water table, reed canarygrass competition.	
Aquatic Vegetation Impact	Severe throughout reach except under established forest buffer. Willow in stream channel.	
Ditches	4.5 miles	
Flooding	Common, widespread, and prolonged.	
Culverts, Fish Barriers	5 (2 stream, 3 ditch) – 2 fish passage barriers	
Beaver Dams	Too numerous to count.	
Fish Utilization	Adult coho migration, juvenile rearing.	
Bacterial Contamination	No data	
Temperature Exceedances	0 days	
Dissolved Oxygen	8.0-9.4 at upstream end of reach.

Farmland Area	266 acres (61% of reach)	
Productive Farmland	101 acres (38% of all farmland), (62% marginal farmland)	
Non-Agriculture Area	170 acres (39% of reach)	
Organic Soils	156 acres, approximately 59% of farmland	
	Downstream Photo	Upstream Field & Riparian Buffer

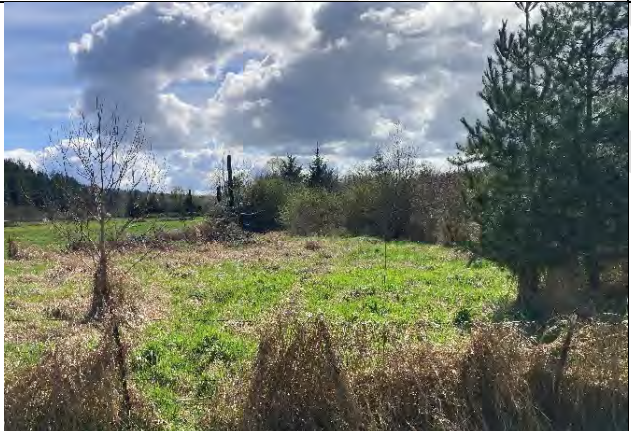
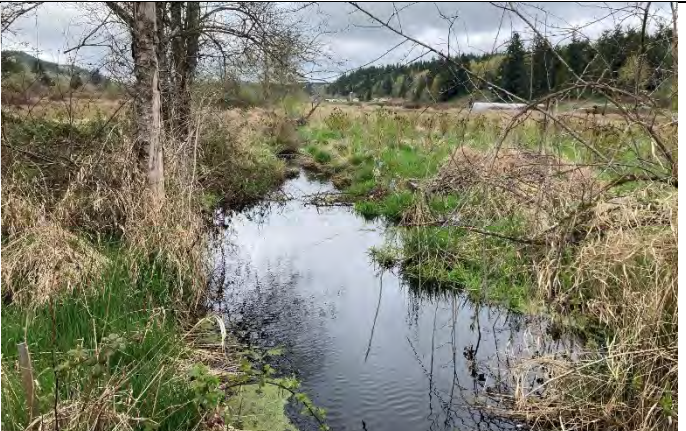
Area, River Miles, Length	434 acres. RM 3.5 to 4.8 – 1.3 miles	
Stream Gradient	0.1-1.0%, steepest in upstream half of reach.	
Channel Conditions	Highly modified with little complexity throughout reach.	
Tributaries	2.3 miles, all unnamed	
Riparian Characteristics and Tree/Shrub Establishment Potential	Well established planted forest buffer along about 0.06 miles near downstream end of reach and narrow buffer on right bank along lowest 0.15 miles of reach. Fair to poor tree and shrub establishment potential.	
Aquatic Vegetation Impact	Severe throughout reach except under established forest buffer.	
Ditches	3.4 miles	
Flooding	Common, widespread, and prolonged.	
Culverts, Fish Barriers	7 (4 stream, 3 ditch) – 2 fish passage barriers	
Beaver Dams	1 identified	
Fish Utilization	Adult coho migration, juvenile rearing.	
Bacterial Contamination	E. coli Geometric Mean = 38 MPN/100 mL; range = 1-156	
Temperature Exceedances	7 days; July-August average daily high = 15.2°C

Dissolved Oxygen	Mean = 8.9 mg/L; range = 7.5-10.1	
Farmland Area	195 acres (45% of reach)	
Productive Farmland	21 acres (11% of all farmland), (89% marginal farmland)	
Non-Agriculture Area	239 acres (55% of reach); includes former farmland no longer farmed	
Organic Soils	225 acres, approximately 100% of farmland	
Downstream Field, Riparian Buffer Looking US - East	Upstream Photo

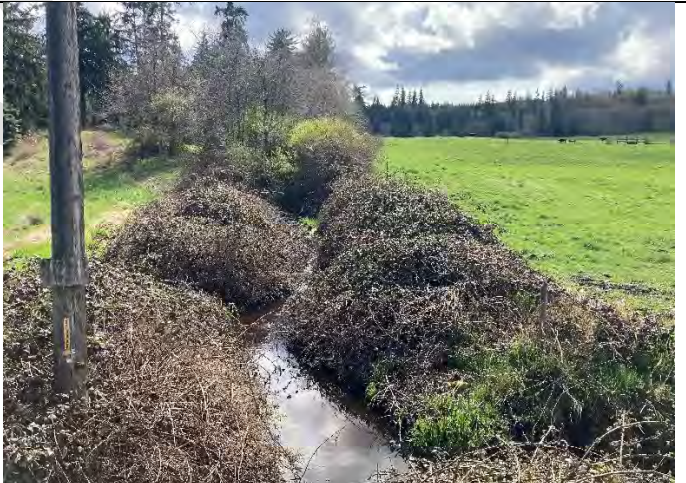
Area, River Miles, Length	490 acres. RM 4.8 to 5.95 – 1.15 miles
Stream Gradient	1.0-2.0+%, steepest in upstream end of reach.
Channel Conditions	Highly modified with little complexity throughout reach.
Tributaries	Swansonville Creek and unnamed – 2+ miles.
Riparian Characteristics and Tree/Shrub Establishment Potential	Well established forest buffer along about 0.09 miles at downstream end of reach, buffer on right bank upstream 0.17 miles to Egg & I Road. Partial forest buffer along about 0.18 miles in vicinity of Swansonville-East Chimacum Creek confluence. Good tree and shrub establishment potential.
Aquatic Vegetation Impact	Severe throughout reach except under established forest buffer.
Ditches	1.85 miles
Flooding	Occasional, not prolonged or destructive.
Culverts, Fish Barriers	15 (10 stream, 5 ditch) – 4 fish passage barriers
Beaver Dams	None identified.
Fish Utilization	Adult coho migration, juvenile rearing.

Bacterial Contamination	E. coli Geometric Mean = 43 MPN/100 mL; range = 2-308
Temperature Exceedances	0 days; July-August average daily high = 13.7°C
Dissolved Oxygen	Mean = 10.0 mg/L; range = 9.1-11.2
Farmland Area	204 acres (42% of reach)
Productive Farmland	135 acres (66% of all farmland), (34% marginal farmland)
Non-Agriculture Area	284 acres (58% of reach)
Organic Soils	113 acres, approximately 55% of farmland
Downstream Photo	Upstream Stream Looking Upstream
